## **PLAY AREA INSPECTION REPORT**

**FOR:  
Holbrook Parish Council  
Recreation Ground Play Area  
Reade Road, Holbrook**

**2<sup>nd</sup> October 2024**

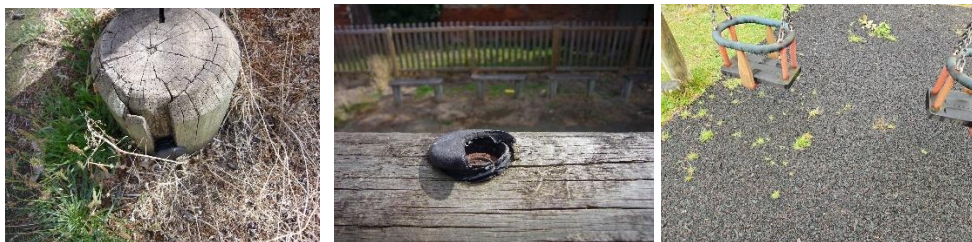
**1.8m high wooden cradle swing.**

- Small support post splitting and delaminating
- 1 top bolt cover damaged
- Grass and weeds have self-seeded into the bonded mulch

**Risk score 6 = Low risk**  
**Risk score 5 = Low risk**  
**Risk score 9 = Medium risk**

If grass and weeds are left untreated in bonded mulch it can irreparably damage the surfacing  
Advise treating with suitable weed control products.

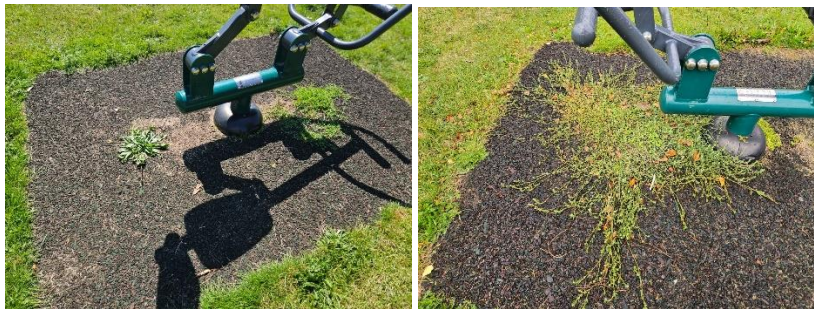
4 Gym Items

- Weeds growing in bonded mulch **Risk score 9 = Medium risk**
- All items in good order with no work required at this point.

If grass and weeds are left untreated in bonded mulch it can irreparably damage the surfacing  
Advise treating with suitable weed control products.

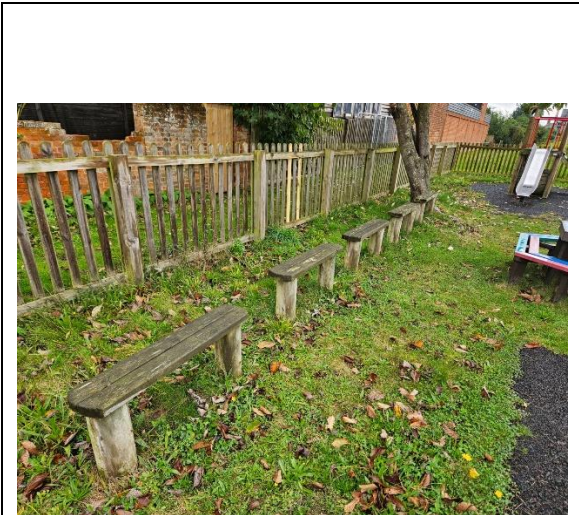
**5 x bench seats**

- Seats positioned close together encouraging climbing.
- Splits and on-set of decay to tops and ends of seats

**Risk score 7 = Low risk**  
**Risk score 4 = low risk**

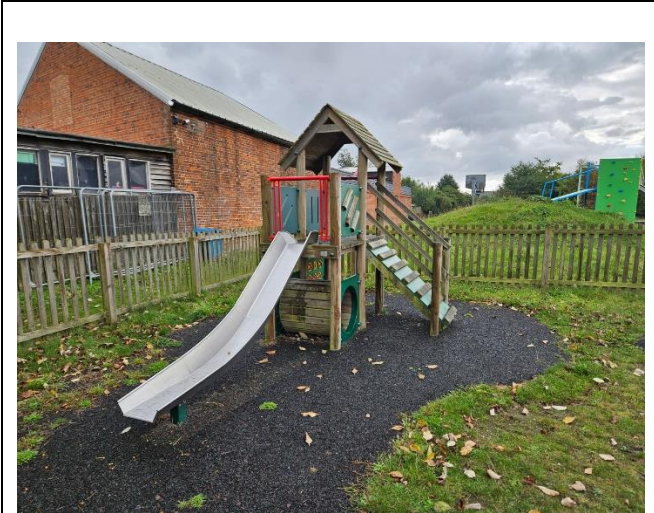
**Wooden multi play unit**

- Non-compliant gap at gable end of roof
- Weeds and grass growing in bonded mulch

**Risk score 4 = Low risk**  
**Risk score 9 = Medium risk**

If grass and weeds are left untreated in bonded mulch it can irreparably damage the surfacing  
 Advise treating with suitable weed control products.

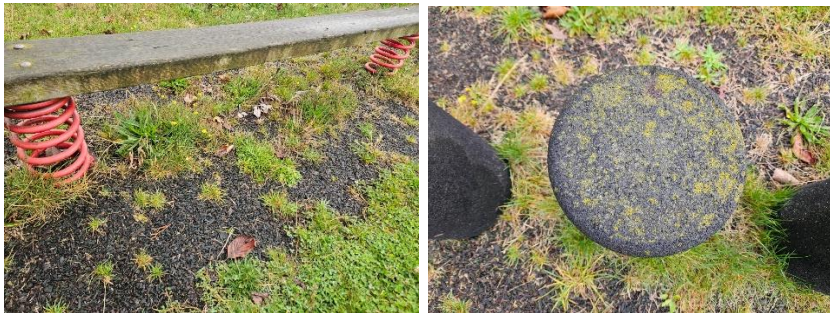
**Step posts and wobble board**

- Excessive weed growth in surface
- Moss and algae on post tops making them slippery

**Risk score 9 = Medium risk**  
**Risk score 8 = Medium risk**

If grass and weeds are left untreated in bonded mulch it can irreparably damage the surfacing  
 Advise treating with suitable weed control products.

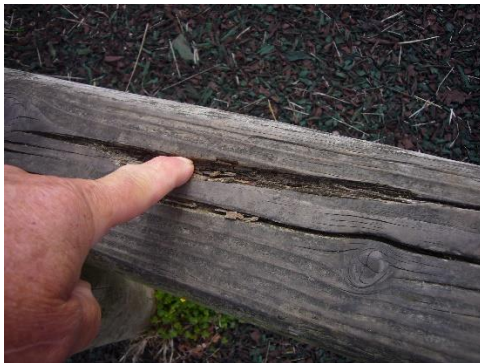
**Weave balance beam and step post**

- Slight splits/shakes in wood
- Grass growing in new surfacing
- Decay in top of balance beam

**Risk score 4 = low risk**

**Risk score 9 = Medium risk**

**Risk score 7 = Low risk**

If grass and weeds are left untreated in bonded mulch it can irreparably damage the surfacing  
Advise treating with suitable weed control products.

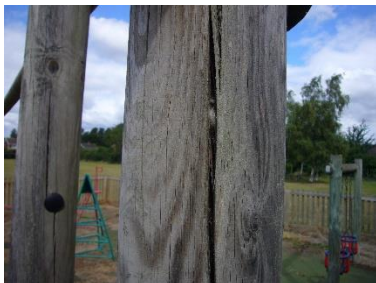
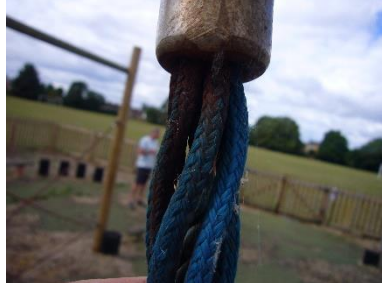
**Trapeze rings**

- Slight splits/shakes in wood
- Grass growing in new surface
- Trapeze rings loose in cross bar
- Trapeze ring ropes delaminating
- Significant bow in crossbar but no rot visible
- Large amount of weed growth in surfacing

- Risk score 4 = low risk**
- Risk score 4 = low risk**
- Risk score 6 = low risk**
- Risk score 6 = low risk**
- Risk score 3 = low risk**
- Risk score 9 = Medium risk**

If grass and weeds are left untreated in bonded mulch it can irreparably damage the surfacing  
Advise treating with suitable weed control products.

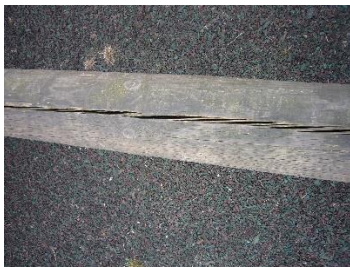
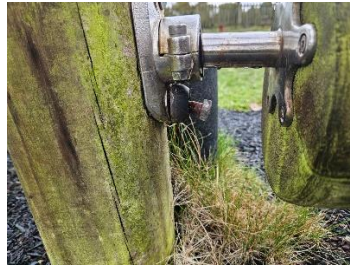
**Spinning balance log**

- Fixing bolt very loose and protruding **Risk score 10 = Medium risk**
- Splits in spinning log **Risk score 4 = Low risk**
- Weeds growing in surface **Risk score 9 = Medium risk**

If grass and weeds are left untreated in bonded mulch it can irreparably damage the surfacing  
Advise treating with suitable weed control products.

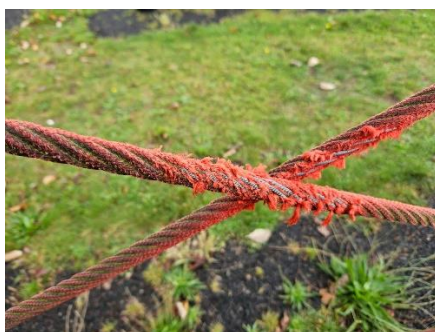
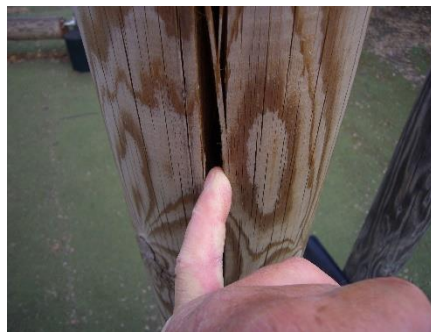
**Swinging step log**

- Cross rope badly worn showing steel braid
- Post loose in ground
- Large shakes/splits in wood
- Large amount of weeds growing in bonded mulch

**Risk score 5 = Low risk**

**Risk score 7 = Low risk**

**Risk score 6 = Low risk**

**Risk score 9 = Medium risk**

If grass and weeds are left untreated in bonded mulch it can irreparably damage the surfacing  
Advise treating with suitable weed control products.

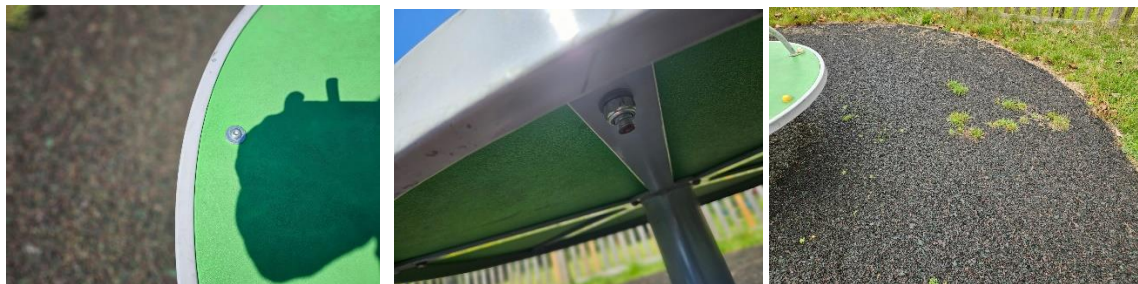
**Mini Whirl**

- Bolt cover cap missing
- Bolt has been fitted incorrectly protruding thread below deck.
- Large amount of weed growth in surfacing

**Risk score 6 = Low risk**  
**Risk score 12 = Medium Risk**  
**Risk score 9 = Medium risk**

If grass and weeds are left untreated in bonded mulch it can irreparably damage the surfacing  
 Advise treating with suitable weed control products.

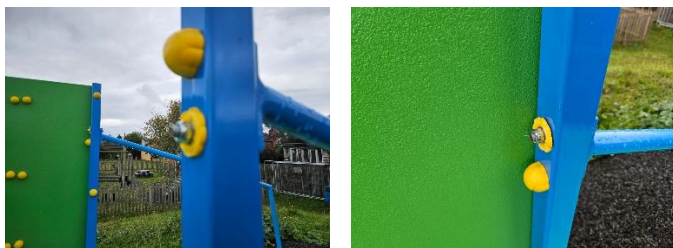
**Mound slide and platform**

- 2 bolt covers have been broken on tower entrance

**Risk score 6 = Low risk**

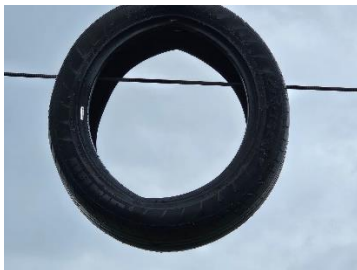
**Aerial runway**

- Tyre buffer needs to be moved to ensure correct space at end of travel. **Risk score 5 = Low risk**

It is recommended that the cable is periodically taken down to inspect it for damage where it passes through the framework.

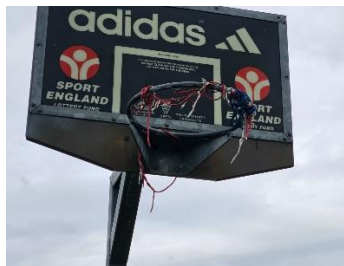
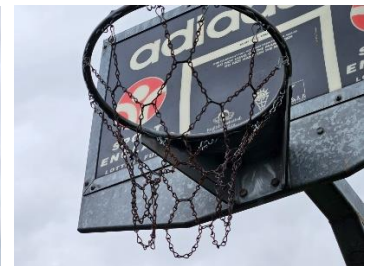
**Basketball pitch**

- Rubber inserts to tarmac surface failing creating trip hazards
- Some raising of tarmac to edge adjacent goal
- Both nets on basketball rings are damaged

**Risk score 9 = Medium risk**  
**Risk score 7 = Low risk**  
**Risk score 7 = Low risk**

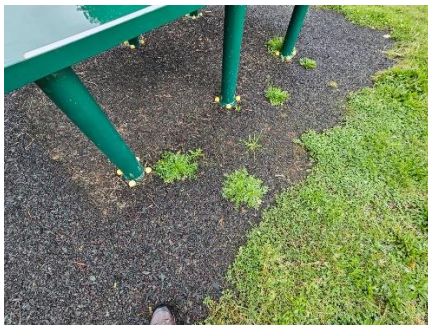
**Ping-pong table**

Large amount of weed growth in surface  
Line tape damaged on tabletop

**Risk score 9 = Medium risk**  
**Risk score 4 = Low risk**

If grass and weeds are left untreated in bonded mulch it can irreparably damage the surfacing  
Advise treating with suitable weed control products.

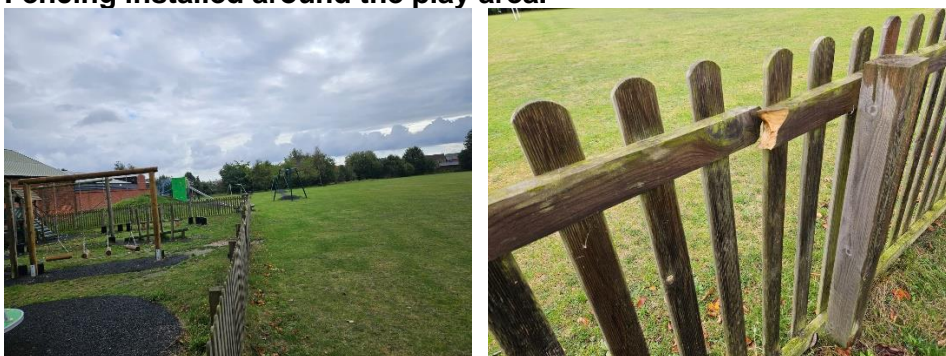
### **Fencing installed around the play area.**

The fencing is in very poor condition with one broken top rail and broken or missing fence slats, there are 8 loose or rotten posts and the second leaf gate at the entrance is not supported as the post is rotten.

**Risk score 10 = Medium risk**

The position of the gate creates an entrapment, gapes of 12mm should be maintained around all gates. The lockable section has a broken latch.

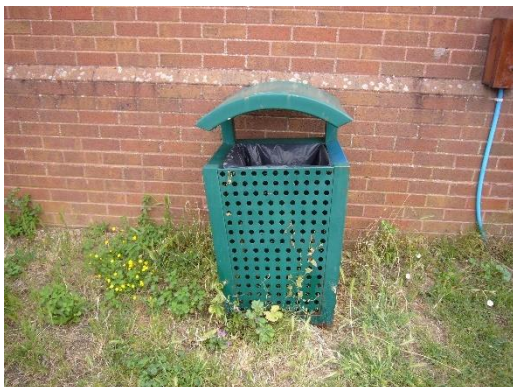
## Litter bins

The green bin is very loose in the ground and can easily be pushed over

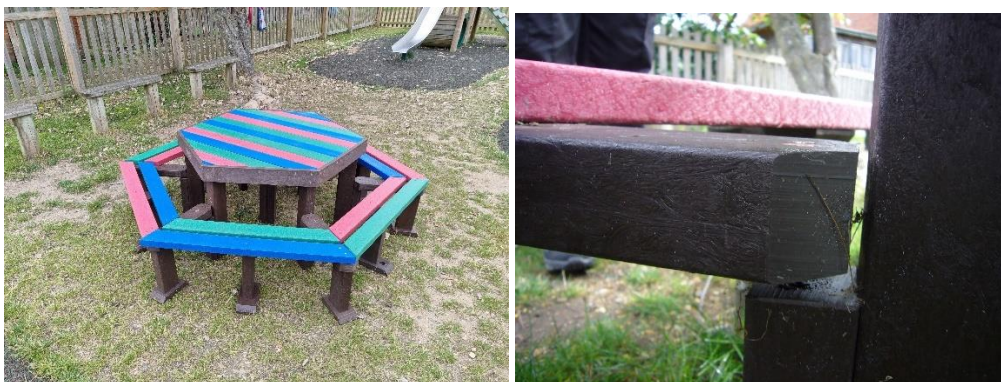
## Bench seat

The bench seat behind the swings has rough edges advise sanding smooth.

The picnic table shown above was in the fence area, it has not been assembled fully and needs to be completed with additional screws

## Risk Score 7 Low Risk
