## **PLAY AREA INSPECTION REPORT**

**FOR:  
Holbrook Parish Council  
Recreation Ground Play Area  
Reade Road, Holbrook**

**2<sup>nd</sup> October 2024**

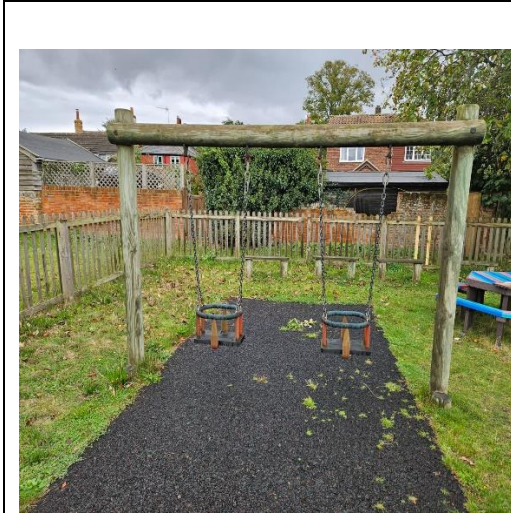
<p>This item meets the requirements of EN 1176 where this may be tested on site without dismantling or destruction.</p>	<p>low</p>	<p>6</p>
---	------------	----------

<p>The surfacing meets the dimensional recommendations of EN 1176.</p>	<p>Low</p>	<p>6</p>
--	------------	----------

- Small support post splitting and delaminating
- 1 top bolt cover damaged
- Grass and weeds have self-seeded into the bonded mulch

If grass and weeds are left untreated in bonded mulch it can irreparably damage the surfacing  
Advise treating with suitable weed control products.

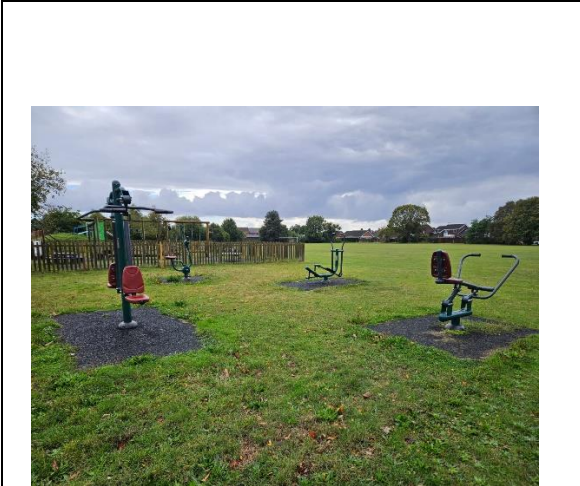
These items meet the requirements of EN 1176	Low	6
--	-----	---

The surfacing meets the dimensional recommendations of EN 1176.	low	6
---	-----	---

If grass and weeds are left untreated in bonded mulch it can irreparably damage the surfacing  
Advise treating with suitable weed control products.

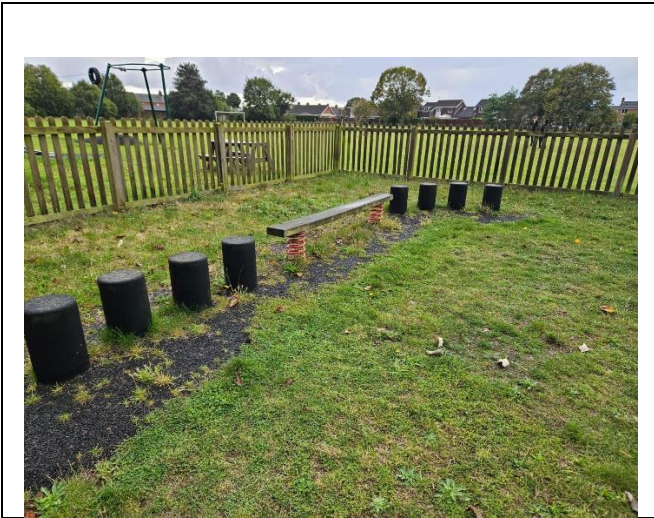
This item meets the requirements of EN 1176 where this may be tested on site without dismantling or destruction.	Low	7
--	-----	---

The surfacing meets the dimensional recommendations of EN 1176.	low	6
---	-----	---

If grass and weeds are left untreated in bonded mulch it can irreparably damage the surfacing  
 Advise treating with suitable weed control products.

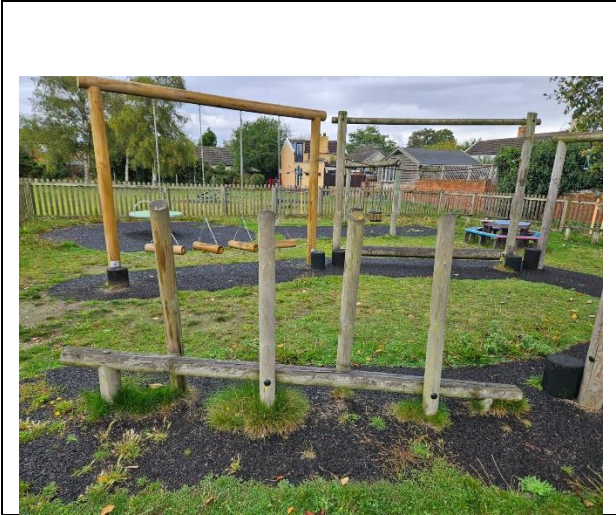
This item meets the requirements of EN 1176 where this may be tested on site without dismantling or destruction.

The surfacing meets the dimensional recommendations of EN 1176.

- Slight splits/shakes in wood
- Grass growing in new surfacing
- Decay in top of balance beam

If grass and weeds are left untreated in bonded mulch it can irreparably damage the surfacing  
Advise treating with suitable weed control products.

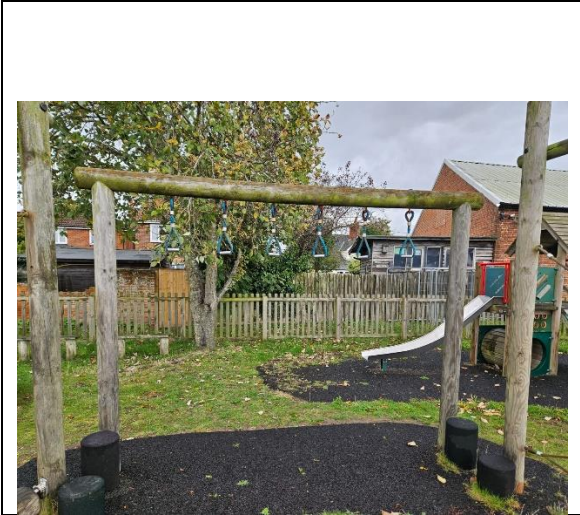
<p>This item meets the requirements of EN 1176 where this may be tested on site without dismantling or destruction.</p>	<p>Low</p>	<p>7</p>
---	------------	----------

<p>The surfacing meets the dimensional recommendations of EN 1176.</p>	<p>Low</p>	<p>6</p>
--	------------	----------

- Slight splits/shakes in wood
- Grass growing in new surface
- Trapeze rings loose in cross bar
- Trapeze ring ropes delaminating
- Significant bow in crossbar but no rot visible
- Large amount of weed growth in surfacing

If grass and weeds are left untreated in bonded mulch it can irreparably damage the surfacing  
Advise treating with suitable weed control products.

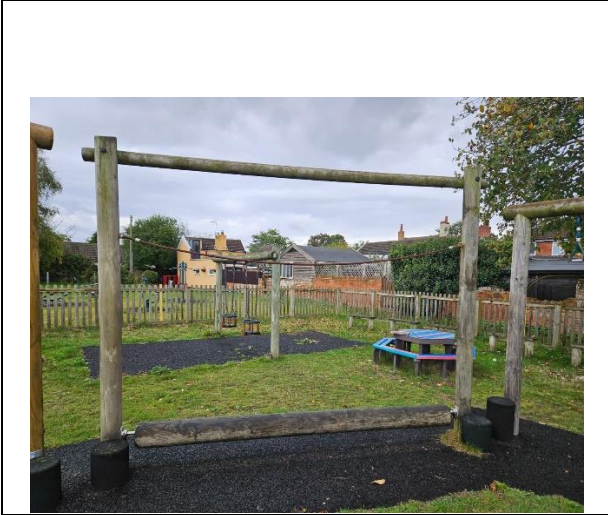
This item fails to meet the requirements of EN 1176	Medium	9
---	--------	---

The surfacing fails to meet the dimensional recommendations of EN 1176.	Low	6
---	-----	---

- Fixing bolt very loose and protruding **Risk score 10 = Medium risk**
- Splits in spinning log **Risk score 4 = Low risk**
- Weeds growing in surface **Risk score 9 = Medium risk**

If grass and weeds are left untreated in bonded mulch it can irreparably damage the surfacing  
Advise treating with suitable weed control products.

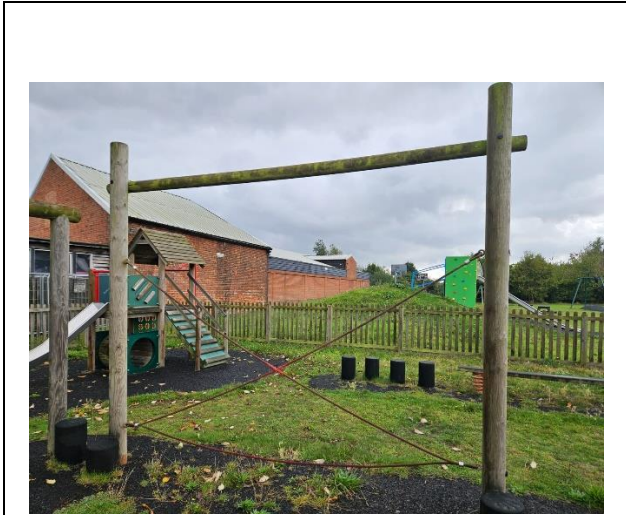
This item meets the requirements of EN 1176 where this may be tested on site without dismantling or destruction.

The surfacing meets the dimensional recommendations of EN 1176.

- Cross rope badly worn showing steel braid
- Post loose in ground
- Large shakes/splits in wood
- Large amount of weeds growing in bonded mulch

If grass and weeds are left untreated in bonded mulch it can irreparably damage the surfacing  
Advise treating with suitable weed control products.

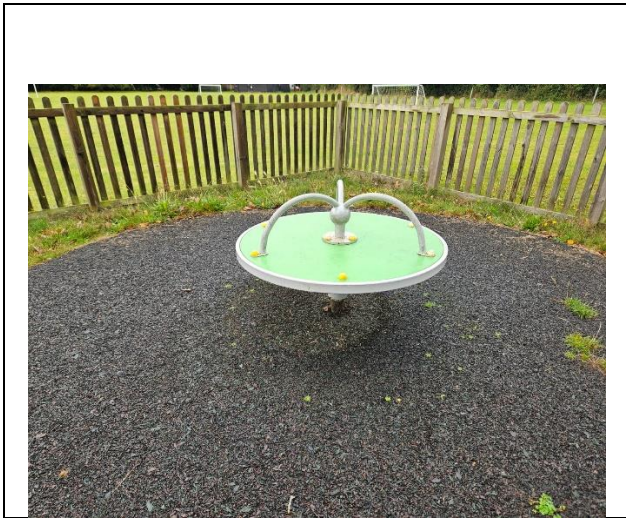
This item meets the requirements of EN 1176 where this may be tested on site without dismantling or destruction.	Low	7
--	-----	---

The surfacing meets the dimensional recommendations of EN 1176.	Low	4
---	-----	---

- Bolt cover cap missing
- Bolt has been fitted incorrectly protruding thread below deck.
- Large amount of weed growth in surfacing

If grass and weeds are left untreated in bonded mulch it can irreparably damage the surfacing  
 Advise treating with suitable weed control products.

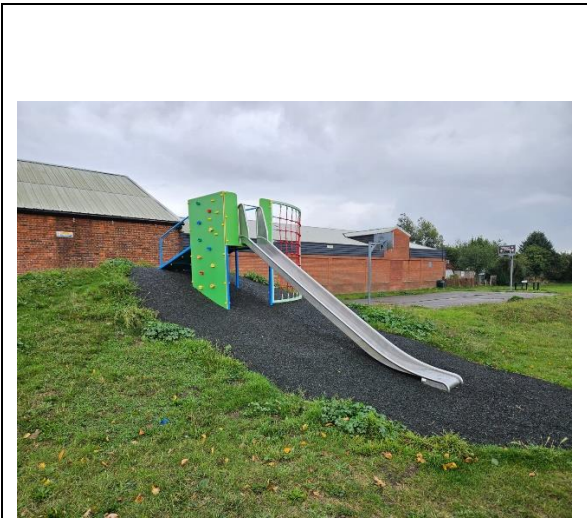
This item meets the requirements of EN 1176 where it can be inspected on site without dismantling or destruction.	Low	6
---	-----	---

The surfacing meet the dimensional recommendations of EN 1176.	Low	4
--	-----	---

- 2 bolt covers have been broken on tower entrance

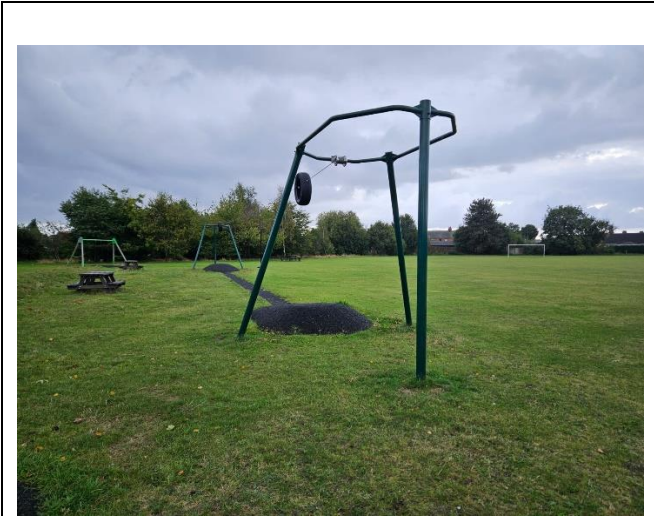
This item meets the requirements of EN 1176 where this may be tested on site without dismantling or destruction.	Medium	8
--	--------	---

The surfacing meets the dimensional recommendations of EN 1176.	Low	5
---	-----	---

It is recommended that the cable is periodically taken down to inspect it for damage where it passes through the framework.

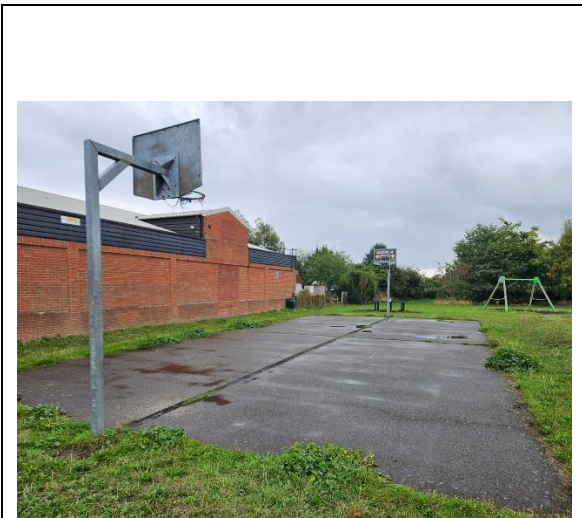
This item meets the requirements of EN 15312 where this may be tested on site without dismantling or destruction.	Low	7
---	-----	---

The surfacing fails to meet the recommendations of EN 1176.	Medium	9
---	--------	---

- Rubber inserts to tarmac surface failing creating trip hazards
- Some raising of tarmac to edge adjacent goal
- Both nets on basketball rings are damaged

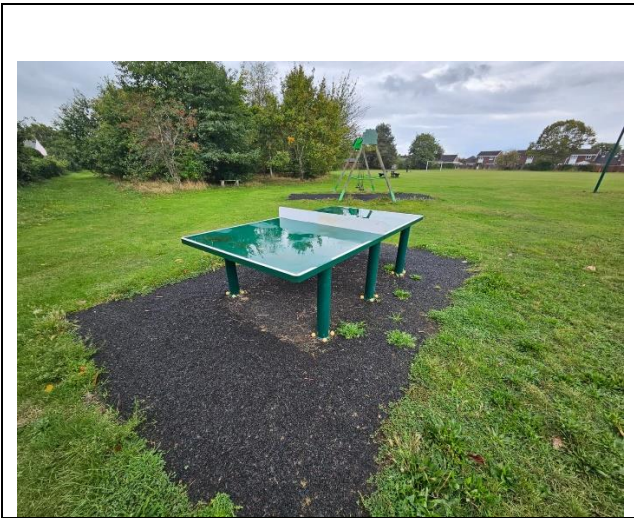
This item meets the requirements of EN 1176 where this may be tested on site without dismantling or destruction.	Low	3
--	-----	---

The surfacing meets the dimensional recommendations of EN 1176.	Low	3
---	-----	---

Large amount of weed growth in surface  
Line tape damaged on tabletop

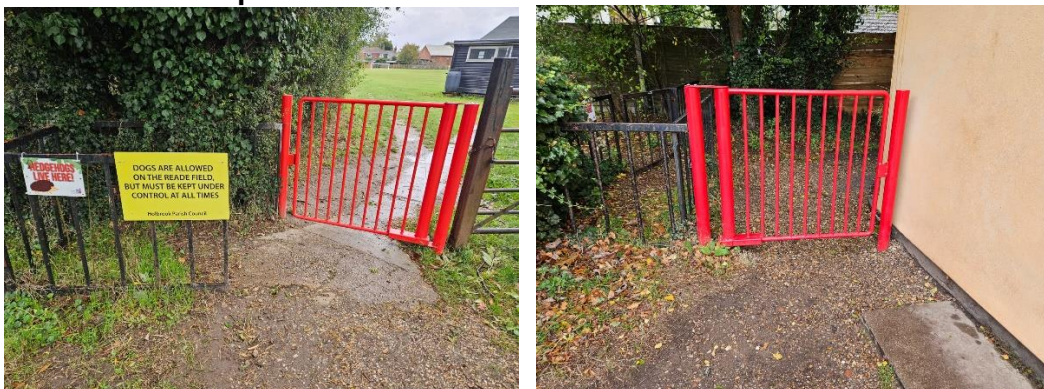
Both gates operate correctly.

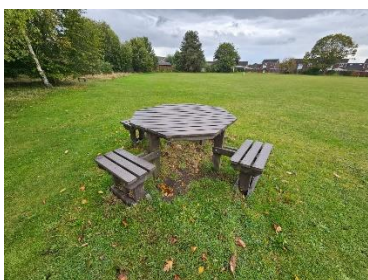
The picnic table is in good order
